Survey No. F-8-116 John Garber Farmstead Johnsville, Maryland Private.

Survey No. F-8-116 John Garber Farmstead Johnsville, Maryland Frederick County

Maryland Historical Trust State Historic Sites Inventory Form

7.1 Description

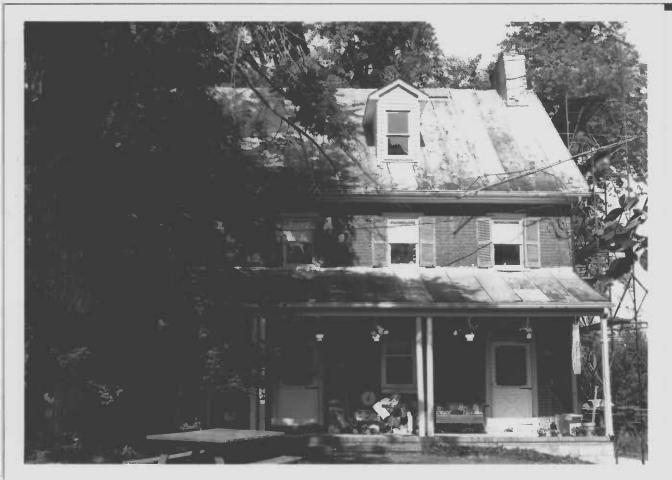
The dwelling house has two stories and a gable roof with its ridge at right angle to the road. Its principal elevation faces east. It has four bays in a flemish bond wall. The other elevations are in 5-course American bond. The bays on the east elevation are irregular, with four complete bays and an extra window opening on the first story. Two doorways are present, one in the north bay and one in the approximate center of the house. This may indicate two building periods, but no other evidence to support this has been documented. A shed porch extends across the elevation on the first story, with chamfered double posts; it appears to be an alteration of the mid 19th century. The doorways and windows have plain architrave trim with header jack arches. The doors are 6 panels with modern storm doors, 4-light transoms and plain The windows are 1/1 and louvered shutters flank the windows on the The roof is standing seam tin with a modern dormer in the east second story. side, just north of center. The side elevations have two bays and interior end On the north elevation, the stone foundation is exposed and rehabilitation work is underway. A sliding glass door has been installed in the northeast corner of the basement level. At the time of survey, scaffolding is in place and repointing appears to be in progress. In each gable end elevation, there are two small square attic level windows with four lights The west elevation is dominated by a one story enclosed porch across the first level. It has eight 6/6 windows and is covered with brick-patterend composition siding. This addition appears to date from the early 20th century. On the second story are two windows with 1/1 sash and louvered shutters.

7-8-110 John Garber Formstead Frederick County Photo: Jonet Dovis June 1991 Neg. loc.: Mol SHPO. Crocensuille md East elevation

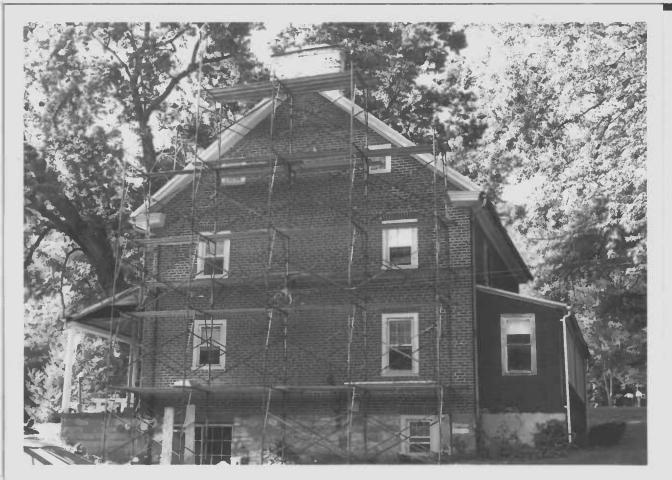
F-8-116 John Garber Formstood Frederick County Photo: Janet Davis June 1991 Neg. loc. i Md. SHPO. Crownsville, Md. North Cloudton 2/6

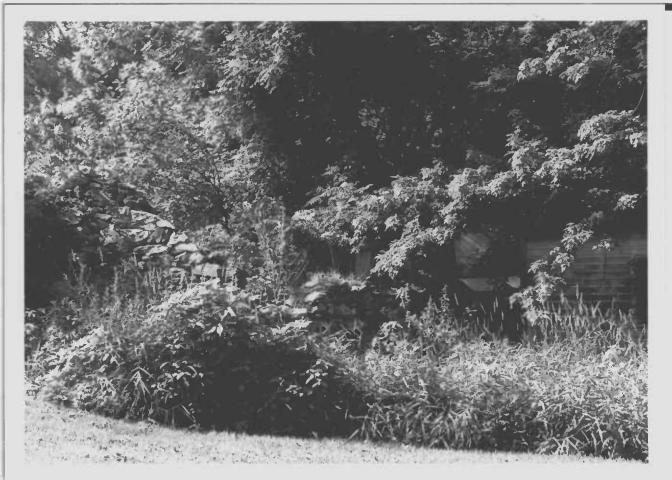
Springhouse ruin: The stone walls of a springhouse are located immediately north east of the summer kitchen. The spring has saturated the ground around both structures. The walls of the springhouse are partially deteriorated, but the structure had a gable roof and a three-bay south elevation with a center entry flanked by windows.

F-8-116 John Gorber Formstood Frederick County Photo: Jonet Davis June 1991 Neg-loc: Md SHPO, Crownsville, Nd Springhouse ruin and partial view of summer Kitchen from north

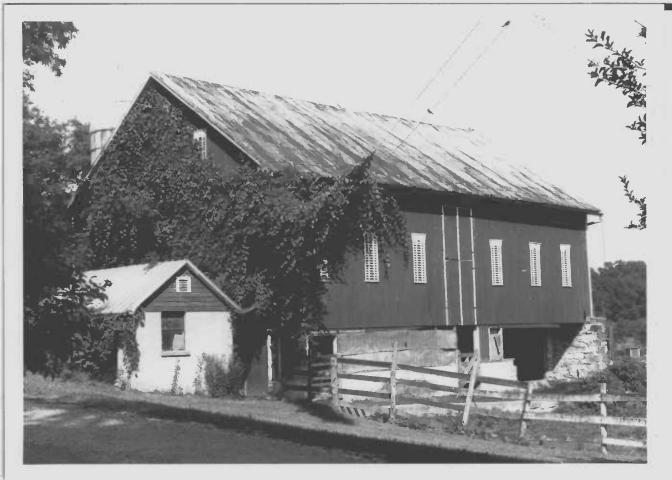
Bank barn: The barn has a stone base and a vertical sided frame upper structure. It is sited at a diagonal to the road with the ramp on the southwest elevation. The forebay on the northeast elevation is partially enclosed, undoubtedly for a milking parlor. This is a typical alteration of the 1930's due to government regulation of the dairy industry. The frame section has decorative vent panel surrounds on all elevations. The roof is both standing seam tin and corrugated metal.

F-8-116 John Gorber Formstead Frederick County Photo: Janet Davis June 1991 Neg. loc: Md. SHPO, Crownsville, Md. Bank born east elevation 4/6

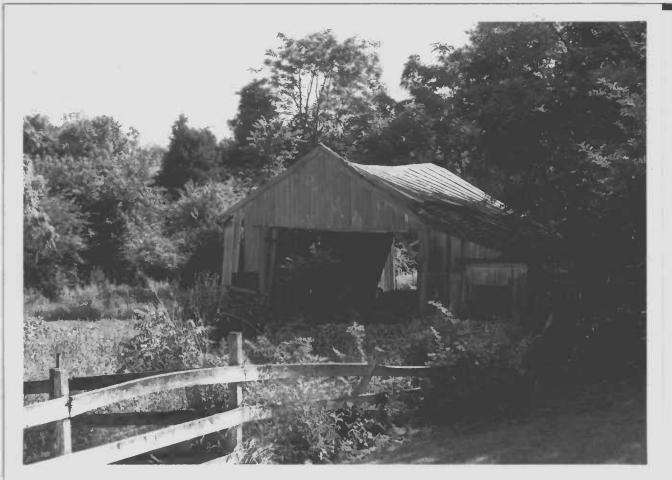
Privy: This is a square frame building with a corrugated metal shed roof and tongue and groove siding. The door is missing. Located near a corn crib in the agricultural outbuilding group, the privy, built in the last quarter of the 19th century, was probably moved from its original location nearer the house at an unknown date.

Pull-through corn crib: This is a double-sided corn crib built about the last quarter of the 19th century. It has vertical siding and a shed for equipment on the north elevation. The standing seam roof is deteriorated and original shingles are visible. The corn crib is now used for storage.

F-8-116 John Garper Formstend Frederick County Photo: Jonet Davis JUNE 1991 Neg. loc .: Md. SHPO Crownsville Md. Corn crib and privy, west elevation 5/6

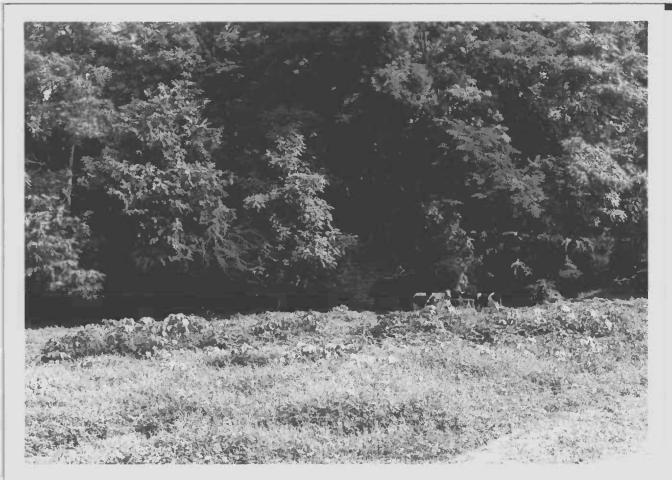
Lime kiln: The kiln is barely visible under heavy vegetation on the cliffside north of the farmstead, but is more easily seen during the winter. It has two arched openings at the base of a rubble stone stack built into the south side of the rock outcrop. The arches are outlined with three courses of header brick. The kiln may have been built in the middle third of the 19th century.

F=8-116 John Gother Farm stead Frederick County Photo: Janet Davis June 1991 Nea. loc: Md. SHPO, Crownsville, Md Lime Kiln, south elevation 6/6
